**FINAL COMPLETION
REPORT
For
COLD FOAM IN PLACE RECLAMATION
Col-20 PM 10.2-28.2**

North Region Materials
Marysville, CA
August 2006

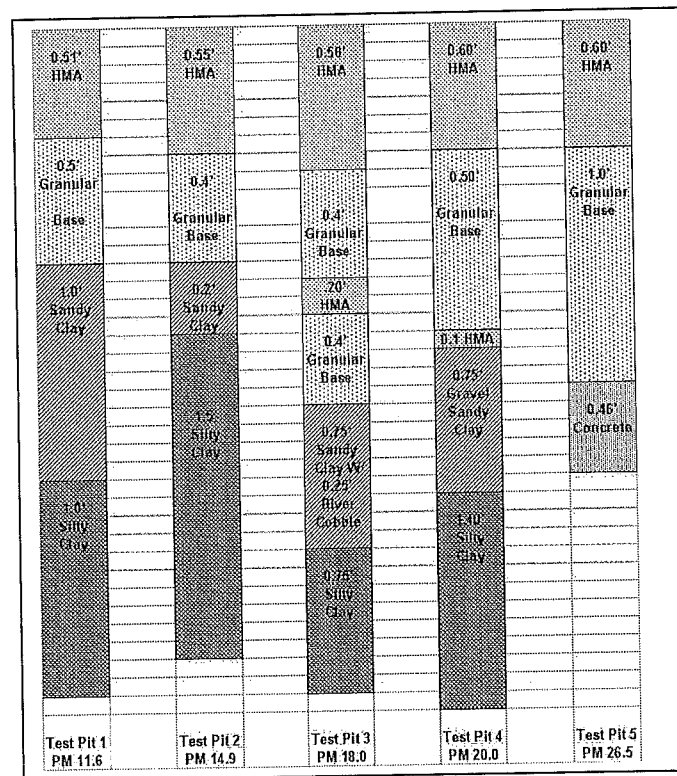
Test Pit Profiles

In early 2000 investigations were carried out by North Region Materials Branch, Marysville and AA Loudon & Partners, Consulting Engineers, Kloof, South Africa. The scope of the investigation was a detailed visual inspection, five test pits to determine existing structural section and native material. Test pits showed silty clay as a native material, a sandy clay that may have been imported, or was the result of farming operations at the turn of the century, granular base and HMA. All test pits showed contamination of upper layers with lower layer material. Test Pit data is shown below:

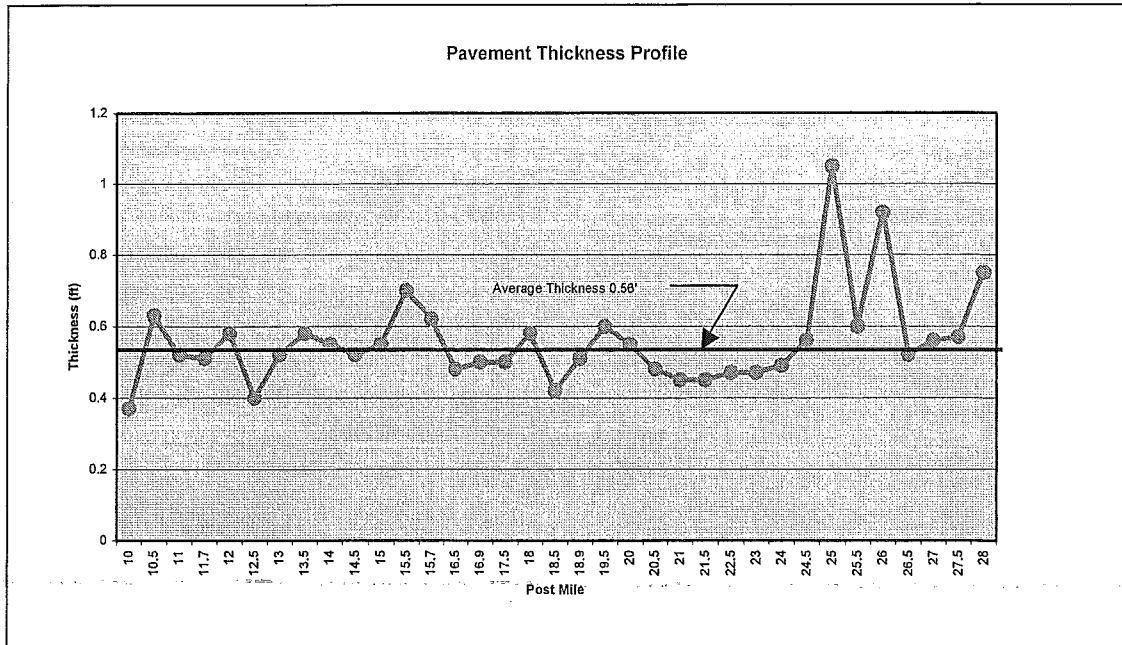
The average HMA thickness was 0.56', with a standard deviation of 0.13 with most cores showing a granular base below the HMA. Pavement profile is shown below:

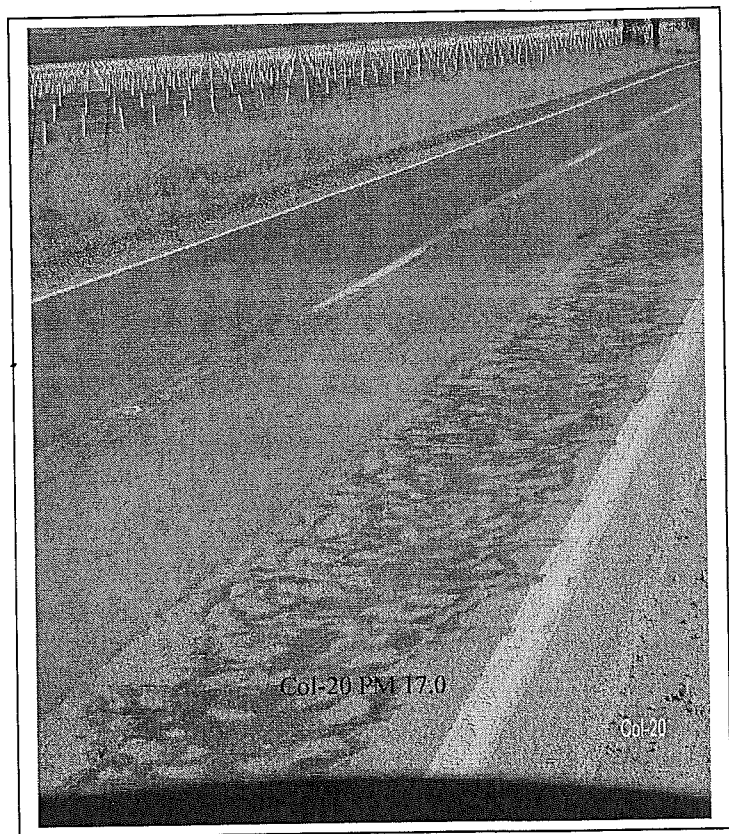
Post construction testing consisted of a detailed field review every 6 months and four deflection studies. Field investigations showed no visible distress for the years 2001-2005. Pavement was intact, with no signs of fatigue or thermal cracking. The maintenance crew reported one lateral crack developing at PM 11.2 in 2005 in the west bound lane. Upon investigation the crack was the result of embankment slippage and loss of lateral support. In July of 2005 another distressed area was identified at PM 17.5 in the eastbound direction. This distressed area coincided with an area that had no base under the HMA and as can be seen in the deflection graph below had the highest deflection of the project. The maintenance crew for the area indicated that the area around PM 17.5 was prone to yearly failures in both directions and wheel paths. At the time of preliminary testing and design, it was assumed that this segment would only last a maximum of two to three years, before remedial work would have to be accomplished.

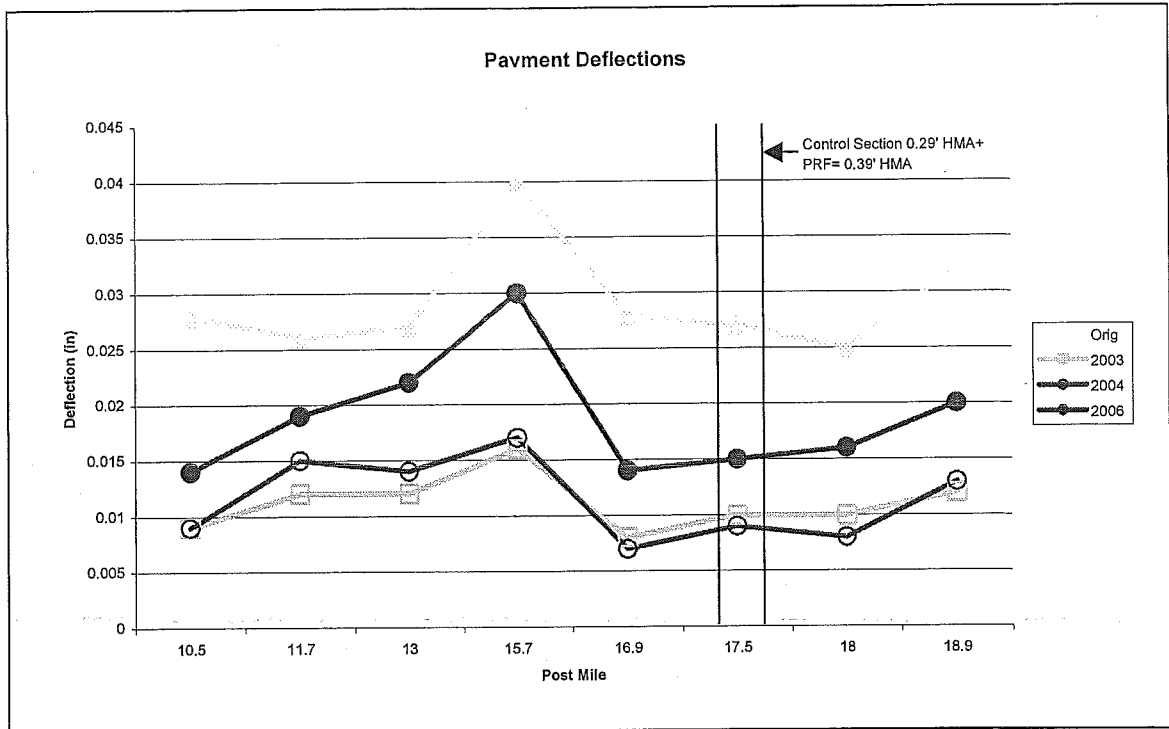
Deflection studies were conducted in 2000, prior to project starting, then again in 2003, 2004 and 2006. Deflection readings were taken in approximately the same location (+/- 200 feet) and lane for all of the studies. As can be seen by the chart below, the highest deflections within the reclamation area occurred at post mile 17.5. This coincides with DCP readings for the area. Statistically, there were little to no changes between 2003 and 2004. Between 2004 and 2006, the average change in deflection was 0.007 inches with a standard deviation of 0.0027. This deflection increase coincides with a record number of

rain days for the 2005 rain season. California saw many road failures from the 2005 winter rains. This pavement, despite the rain and high water table, has performed well.

Under current rehabilitation guidelines based on 0.15 feet of HMA, and a Traffic Index of 9.0, the allowable deflection is 0.24 inches. Using the data from 2006 the average deflection was 0.018, with the 80th percentile being 0.020 inches, which is well under the allowable deflection.

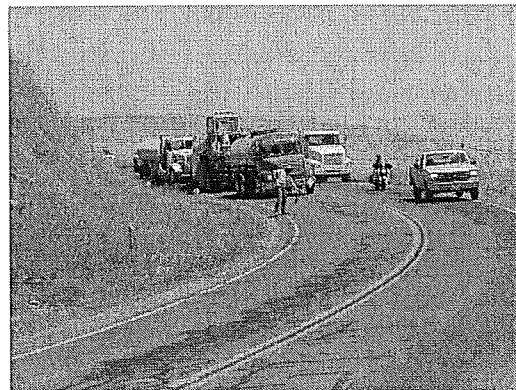
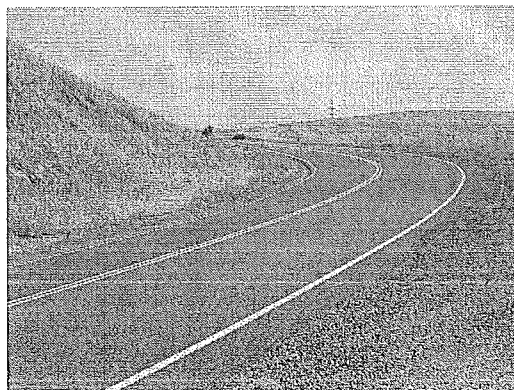
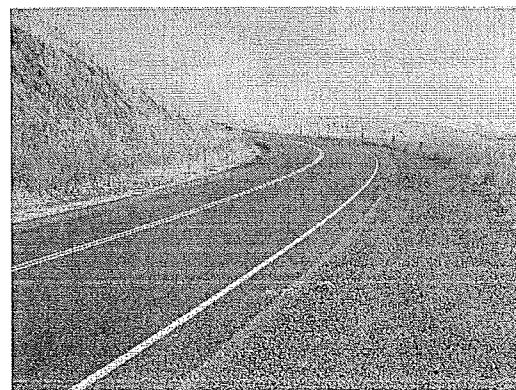
Photos, taken from approximately the same vantage point (14% super elevation) just prior to reclamation and then again in 2004 and 2006 show the pavement performing well, with no signs of lateral displacement of the HMA mat, or any longitudinal cracking of HMA or stabilized base.
