**FINAL COMPLETION
REPORT
For
COLD FOAM IN PLACE RECLAMATION
Col-20 PM 10.2-28.2**

North Region Materials
Marysville, CA
August 2006

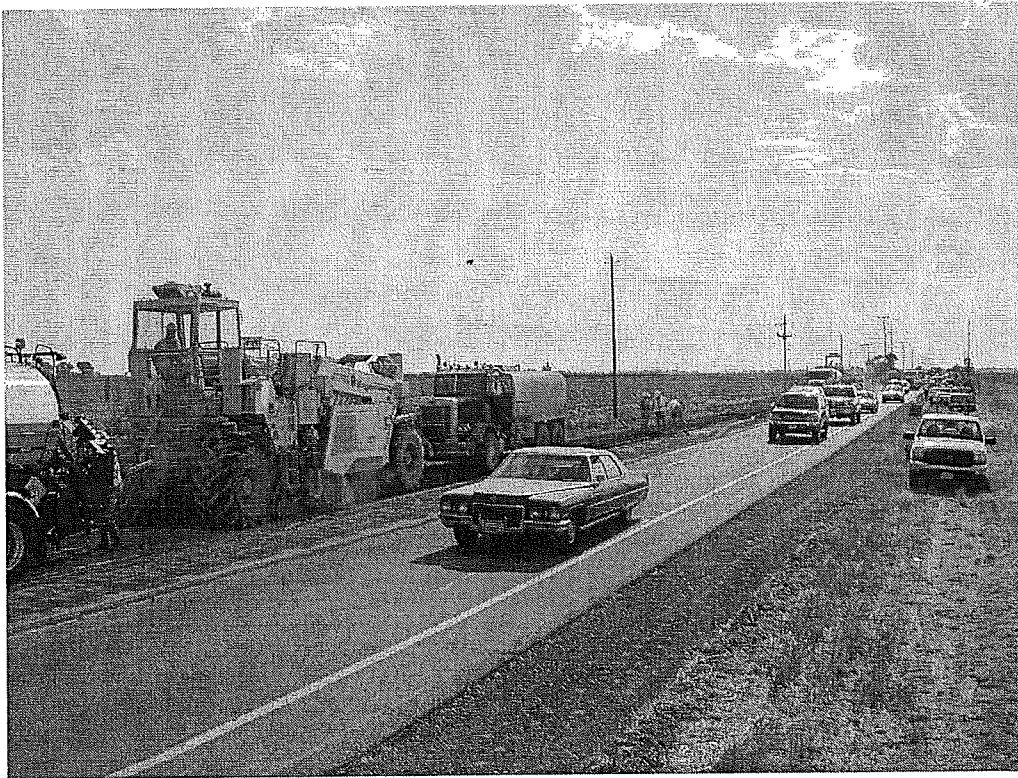
In July 2001, construction began on the project. The prime contractor was Baldwin Construction and the recycling contractor was Western Stabilization. All testing done on the recycled material was performed by Caltran's North Region Materials, Marysville. Two recycling trains were used for this project. By utilizing the two trains, one lane could be recycled in one pass. This also minimized the ingress and egress of construction trucks into the traffic control. All recycling was done during daytime closures with one-way traffic control.

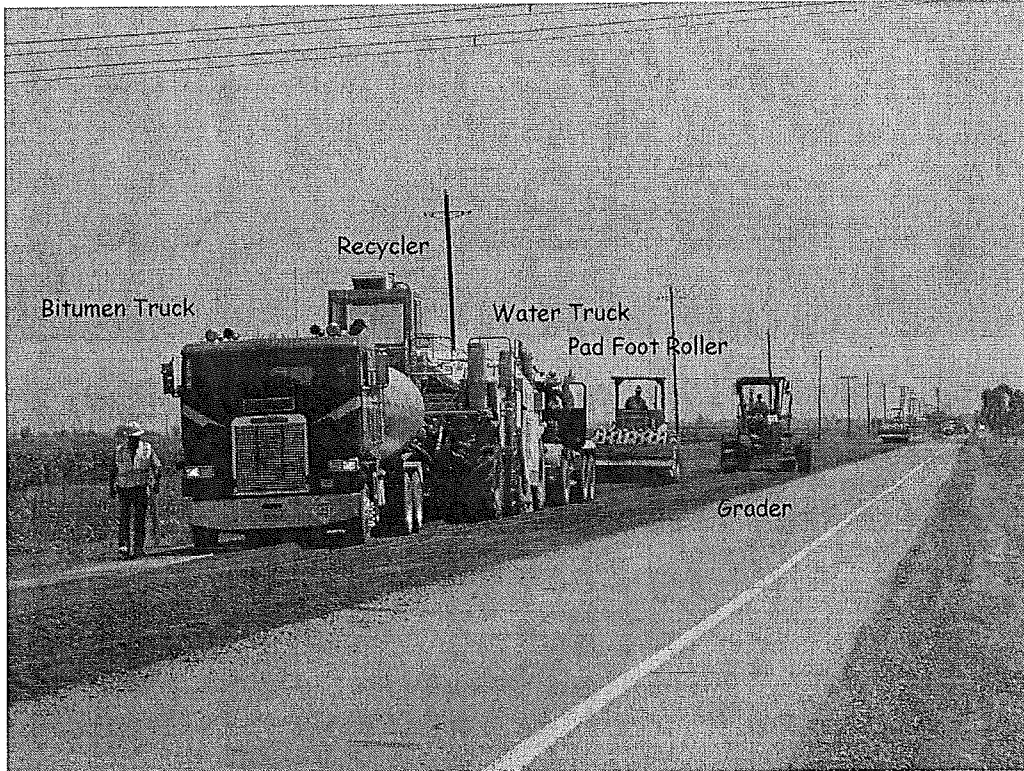
Recycling began at PM 20.0 heading westbound in the westbound lane. The pavement was recycled together with foamed oil and cement. The pads foot roller would then make an initial pass to compact the uncompacted material between the wheels of the recycler and back drag to level out the material. The pad foot would then continue until the roller walked itself out of the material, approximately three coverages. Next, the grader would cut the material to rough profile and cross slope but leave it about 1" high. The steel drum roller would then make three coverages with the vibratory on. The grader would come back in and cut the material to desired profile by hanging the blade on the centerline of existing and setting the blade to the desired cross slope. One final coverage with the steel drum roller, with the vibratory off, to iron the finish.

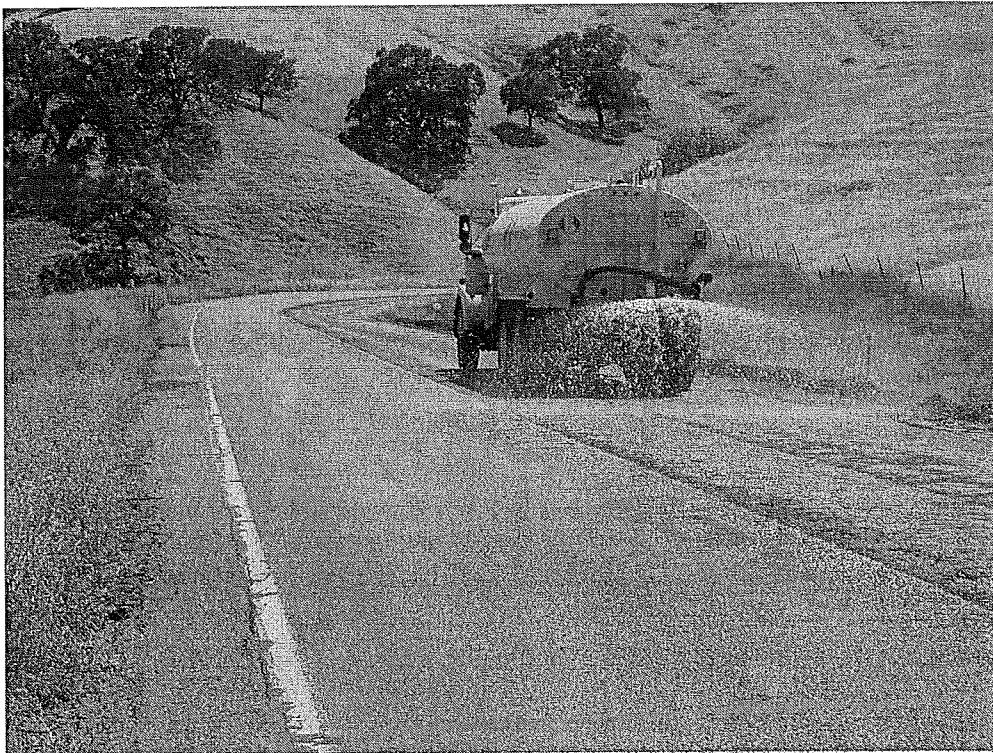
Sweeping to remove any loose material was required prior to releasing traffic on the recycled material. Each recycled segment was lightly watered three to four times a day for at least two days. After the first night of traffic running on the recycled material, it was determined that sweeping the day after a segment was recycled would also be required. This resulted in no windshield breakage claims.
